# Balcony Problems with Added Sliding Glass Doors

BY DONALD  
CHALAIRE, PE

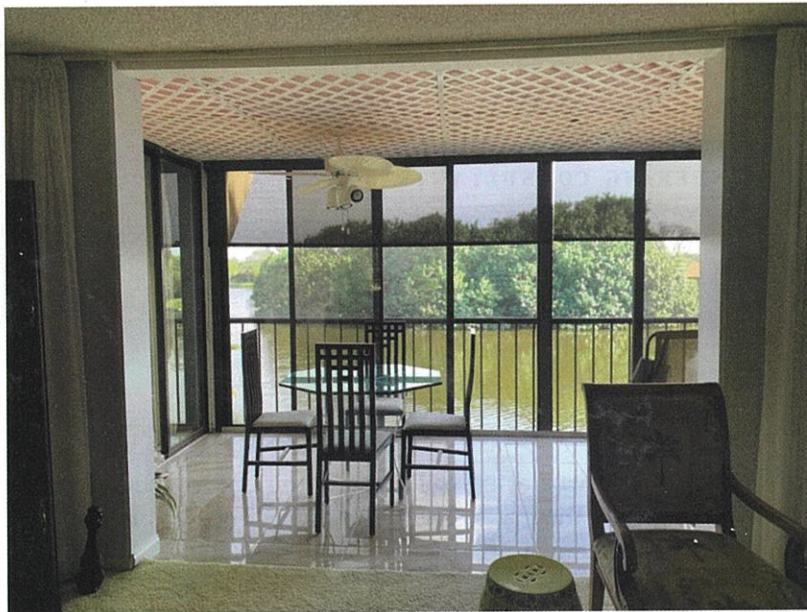
Photos courtesy of Chalaire & Associates—Inner SDG Removed

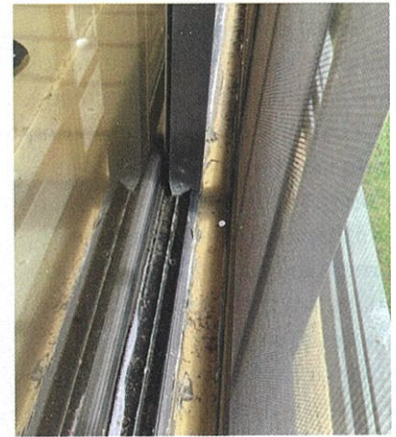
Debris

4. At one unit, the SGDs at the edge have two fixed panels and one movable panel at the middle. When the center movable panel is in the closed position, the empty side of the track is toward the interior at the left panel, and the empty side of the track is toward the exterior at the center and right panels. The bottom track also was filled with debris.

1. At one unit, recommendations included cleaning and checking for weep holes to ensure the bottom track is shedding water as quickly as possible. If they are blocked or caulking is found to be blocking the weep holes, rework as required. Water in tracks is normal.
2. At the other locations, the contractor was asked to seal the hidden slab cracks by pressure epoxy injection or hydro-active grout at each side of the SGD bottom tracks. This may require removal of some railing and/or screen framing.
3. As expected, cleaning and re-caulking the exterior side of SGD framing always helps. ■

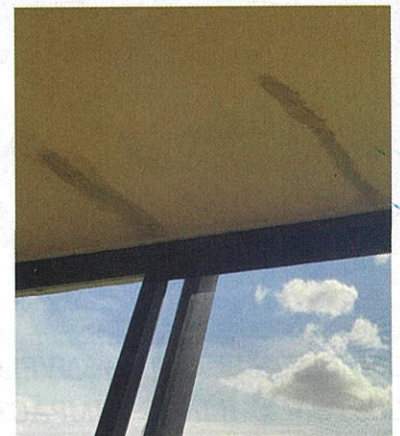
Unpainted Crack Repairs

6. At another unit, there were visible shrinkage cracks at the ceiling. They have been painted. There are visible previous crack repairs at the edge.

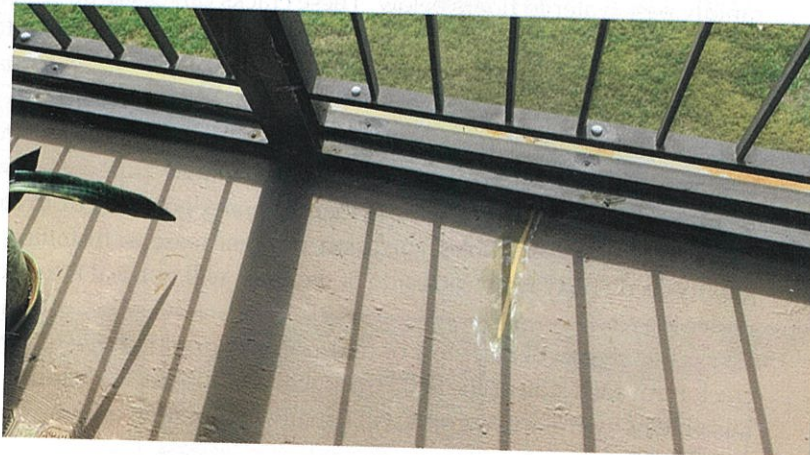
Gravity Feed Epoxy

5. At another unit, the slab edge had several shrinkage cracks that have already been sealed with gravity feed epoxy, on both inside and exterior sides of the SGD.

12. If shrinkage cracks occurred after the SGDs were reinstalled and the bottom tracks are covering a crack, the crack is likely to pass any water that is under the bottom track, whether the water got there from caulking problems, fastener holes, corrosion, or other reasons. Installing gravity-feed epoxy from each side of the track will not seal the crack under the track.

13. Pressure-injection of an epoxy or hydro-active grout into the concrete crack from each side of the SGD track will seal the crack. Pressure injection of hydro-active grout will usually seal hidden or non-accessible cracks.

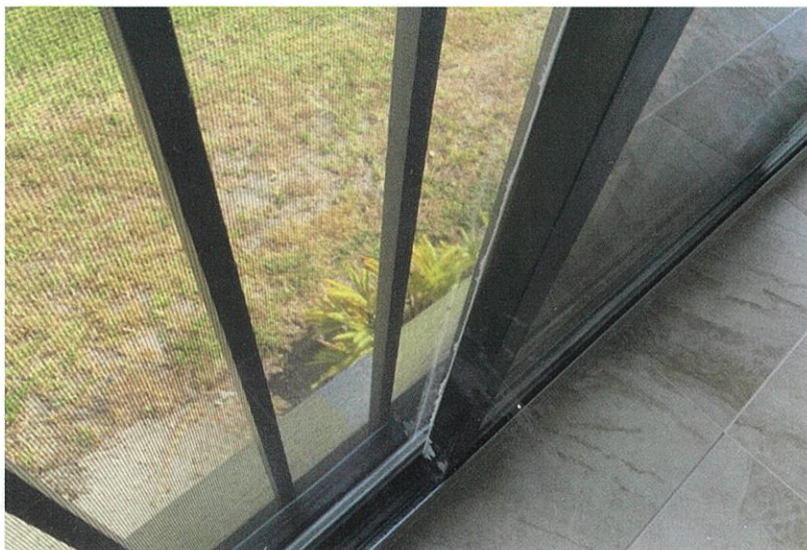
Balcony Floor Tile

11. Water passing through slab cracks will cause water to be seen on floors below, so concrete with shrinkage cracks exposed to rainwater will rapidly pass water to floors below. These cracks can easily be sealed with gravity-feed or injected epoxy. However, there is no hope if floor tile was installed above the cracks. Floor tile on balconies—well, that would be another article.

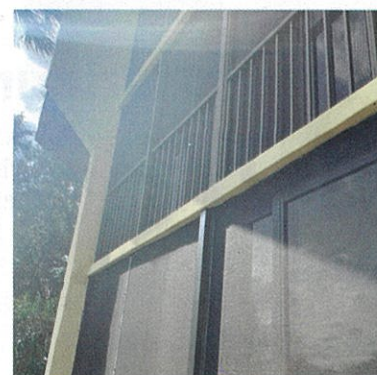
Slab Edge

1. There is caulking installed at the exterior side of all of the SGD framing between the aluminum and concrete surfaces.
2. There were a few concrete or stucco cracks at the slab edges. Some were not sealed.
